## AIRMUNITIONS TEST REPORT

HAZARD CLASSIFICATION OF M50  
IGNITER FOR M58A2 ROCKET IN  
GAR ID/2A

HAZARD CLASSIFICATION OF M50 IGNITER

FOR M58A2 ROCKET MOTOR IN GAR 1D/2A

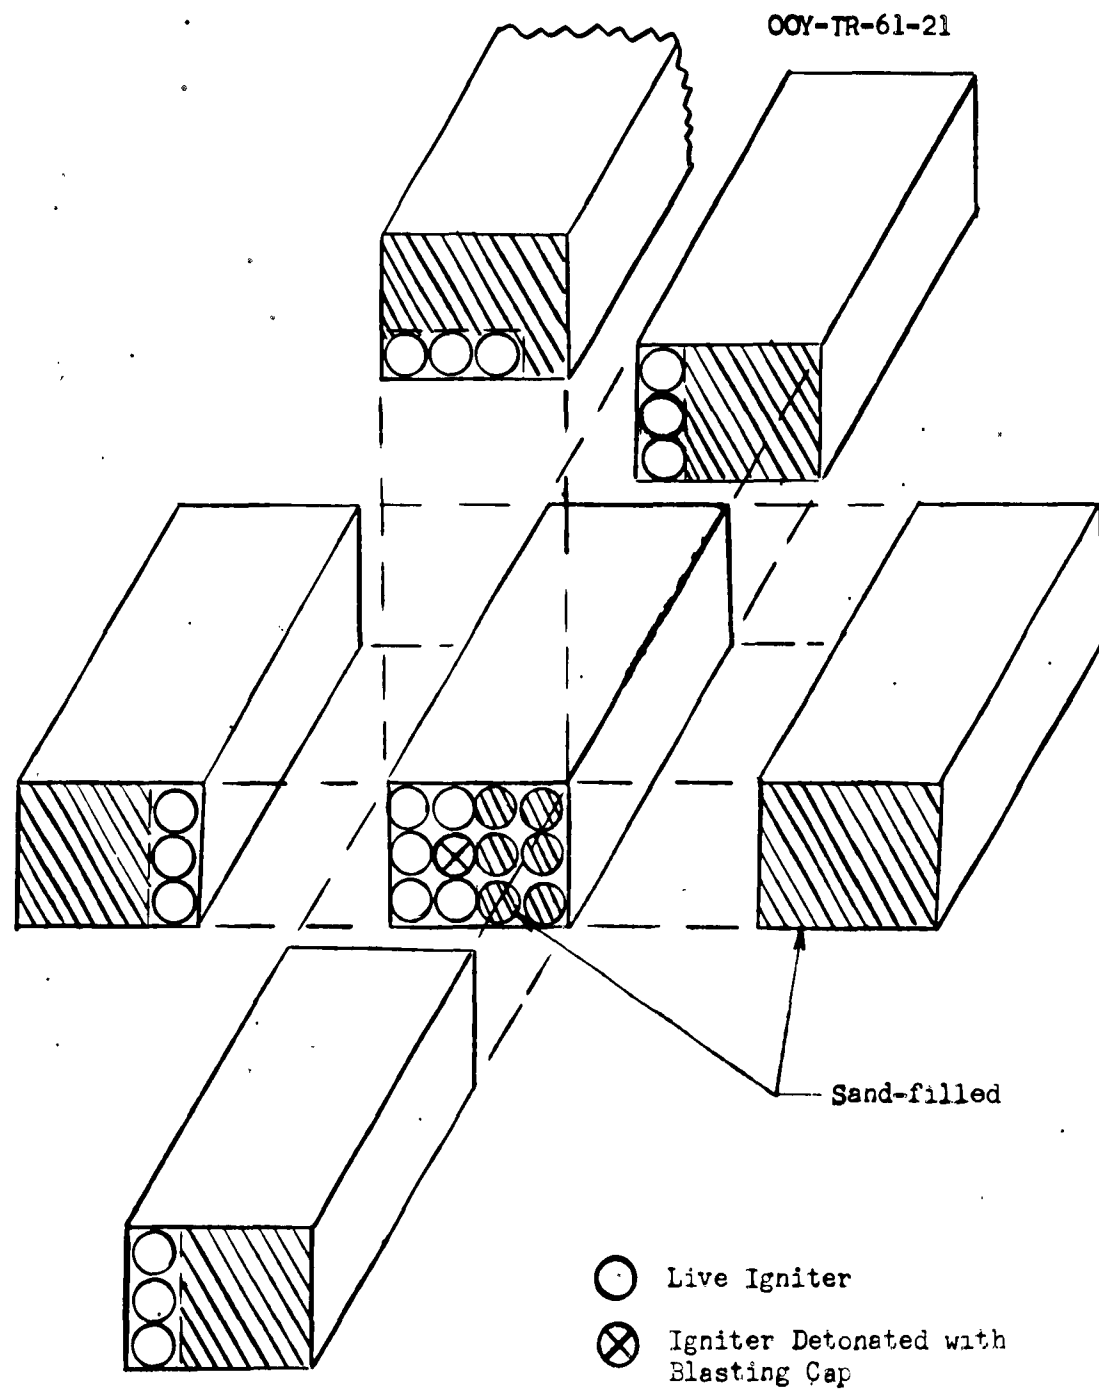
FIGURE 10. Exploded View of Detonation Tests 5 and 6 - Propagation Between Boxes.

Six live igniters in their shipping containers were placed in a wooden box. One of the igniters was primed with a blasting cap. The wooden box was restrained or confined on all sides by other boxes which had a row of igniters in positions adjacent to the igniters in the first box (Figures 9 and 10). The remaining volume of the boxes was filled with sand. Figure 11 shows the igniters in the container cans less the saddle which forms the cover of the containers. Note that the containers are sealed with tape.
